ONEFLOR USA ACOUSTICAL PERFORMANCE TEST REPORT

ASTM E90 AND ASTM E492 TESTING ON
3.5 MM ONEFLOR USA SETAGRIP/SETADB/CLING/CLING COMFORT LVT FLOORING

Concrete Slab - 203 mm

P6745.02-113-11-R0

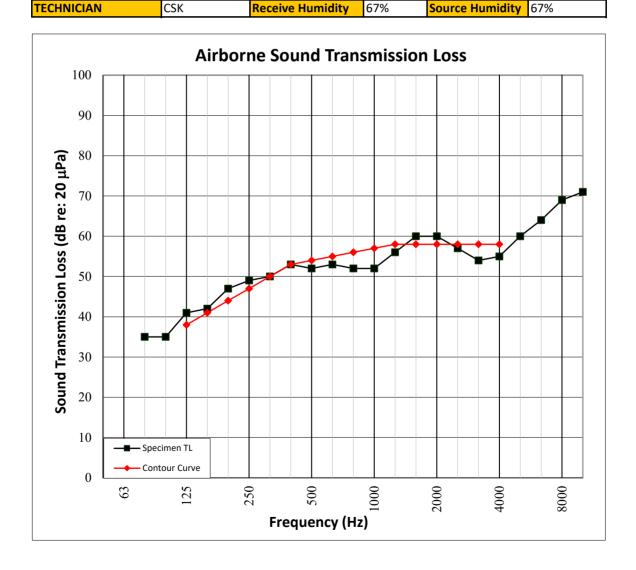
TEST RESULTS - AIRBORNE SOUND TRANSMISSION LOSS GRAPH

FREQ	BACKGROUND	ABSORPTION	SOURCE	RECEIVE	SPECIMEN	95%	NUMBER
FREQ	SPL	ABSURPTION	SPL	SPL	TL	SAMPLING	OF
(Hz)	(dB)	m²	(dB)	(dB)	(dB)	LIMIT	DEFICIENCIES
50	38.8	31.1	109	71	35	2.9	-
63	35.2	17.5	107	66	40	5.2	-
80	29.5	14.4	102	67	35	3.6	-
100	24.2	9.6	100	67	35	1.9	-
125	26.9	9.0	103	64	41	2.3	0
160	25.8	8.9	101	62	42	1.0	0
200	20.7	9.7	98	53	47	2.0	0
250	17.8	11.7	100	52	49	1.0	0
315	20.5	10.3	104	55	50	1.1	0
400	18.8	8.8	104	53	53	0.7	0
500	18.3	8.3	100	49	52	0.9	2
630	21.0	8.2	98	46	53	0.6	2
800	21.4	8.5	99	49	52	0.7	4
1000	23.3	8.8	100	48	52	0.4	5
1250	19.7	9.0	100	45	56	0.7	2
1600	16.7	9.1	100	41	60	0.4	0
2000	13.7	9.5	100	40	60	0.4	0
2500	10.9	10.7	95	38	57	0.4	1
3150	9.0	11.5	93	39	54	0.6	4
4000	8.7	12.3	93	37	55	0.5	3
5000	8.9	14.1	91	30	60	0.6	-
6300	9.5	17.0	88	22	64	0.7	-
8000	10.1	21.2	91	18	69	1.1	-
10000	10.7	21.2	89	15	71	1.6	-
STC Ratin	<mark>g</mark> 54	(Sound Transmi	ssion Class)		Sum o	f Deficiencies	23

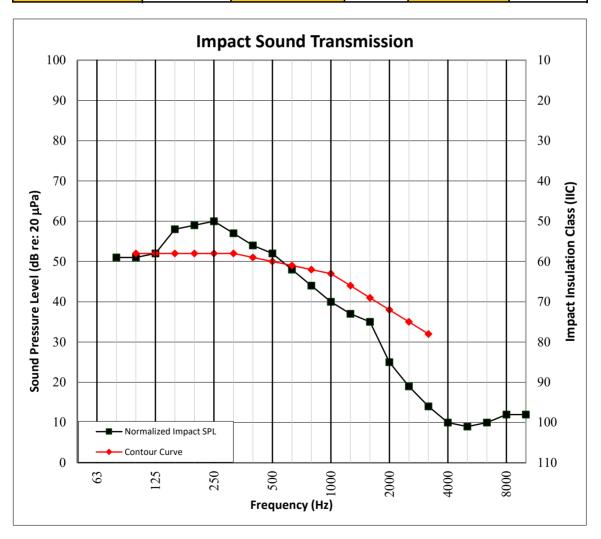
TEST RESULTS - IMPACT SOUND TRANSMISSION GRAPH

FREQ	BACKGROUND SPL	ABSORPTION	NORMALIZED IMPACT SPL	95% SAMPLING	NUMBER OF
(Hz)	(dB)	m²	(dB)	LIMIT	DEFICIENCIES
80	30.7	14.6	51	2.6	-
100	25.1	8.3	51	1.8	0
125	25.0	9.1	52	1.0	0
160	23.3	9.2	58	0.9	6
200	20.0	10.6	59	0.8	7
250	18.6	11.1	60	1.2	8
315	24.4	10.7	57	0.7	5
400	18.3	9.1	54	0.6	3
500	16.8	8.5	52	0.5	2
630	20.7	8.2	48	0.5	0
800	21.3	8.6	44	0.7	0
1000	22.5	8.8	40	0.8	0
1250	19.1	9.1	37	0.5	0
1600	15.9	9.0	35	0.6	0
2000	13.3	9.4	25	0.8	0
2500	10.8	10.5	19	0.8	0
3150	9.0	11.4	14	0.6	0
4000	8.6	12.4	10	0.3	-
5000	8.9	14.3	9	0.3	-
6300	9.5	17.1	10	0.3	-
8000	10.1	21.0	12	0.4	-
10000	10.6	21.0	12	0.4	-
IIC Ratio	ng 60	(Impact Insula	tion Class)	Sum of Deficienci	es 31

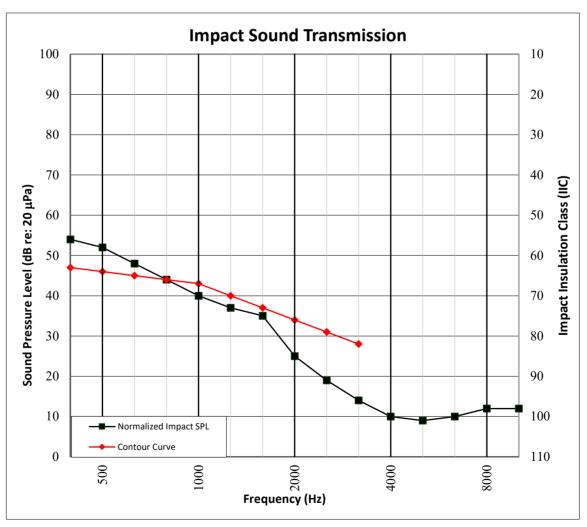
TEST RESULTS - HIGH-FREQUENCY IMPACT SOUND TRANSMISSION GRAPH

FREQ	BACKGROUND SPL	ABSORPTION	NORMALIZED IMPACT SPL	95% SAMPLE CONFIDENCE	NUMBER OF
(Hz)	(dB)	m²	(dB)	LIMIT	DEFICIENCIES
400	18.3	9.1	54	0.6	7.3
500	16.8	8.5	52	0.5	6.4
630	20.7	8.2	48	0.5	3.0
800	21.3	8.6	44	0.7	0.0
1000	22.5	8.8	40	0.8	0.0
1250	19.1	9.1	37	0.5	0.0
1600	15.9	9.0	35	0.6	0.0
2000	13.3	9.4	25	0.8	0.0
2500	10.8	10.5	19	0.8	0.0
3150	9.0	11.4	14	0.6	0.0
HIIC Ra	ting 64	(High-Frequen	cy Impact Insulation Class)	Sum of Deficienci	es 16.8

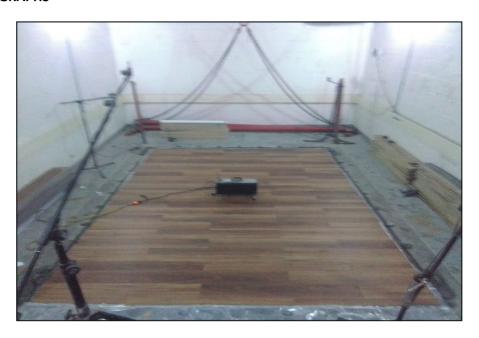
Photo No. 1 Source Room View of Test Specimen Installation

The full test specimen was assembled on the day of testing by B&C. All materials provided by the client were installed on an existing B&C assembly (Concrete Slab - 203 mm) utilizing B&C-supplied materials. The assembly was installed in a steel test frame which was installed into the opening between the source and receive rooms in the test chamber. The test frame was isolated from the structure with dense neoprene gasket.

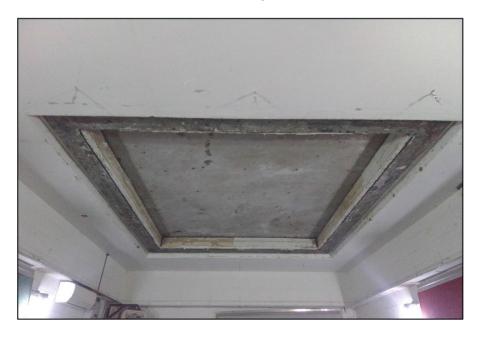
Photo No. 2 Receive Room View of Test Specimen Installation
